Building & Pest Inspection

Saurus Constructions PTY LTD

Pest And Building Inspection

The Scope of the Inspection: This report Complies with Australian Standards AS 4349.1-2007. Inspection of Buildings Part 1: Pre- Purchase Inspections-Residential Buildings- Appendix "C" and with AS 4349.3-2010 (Visual Timber Pest Inspection Report)

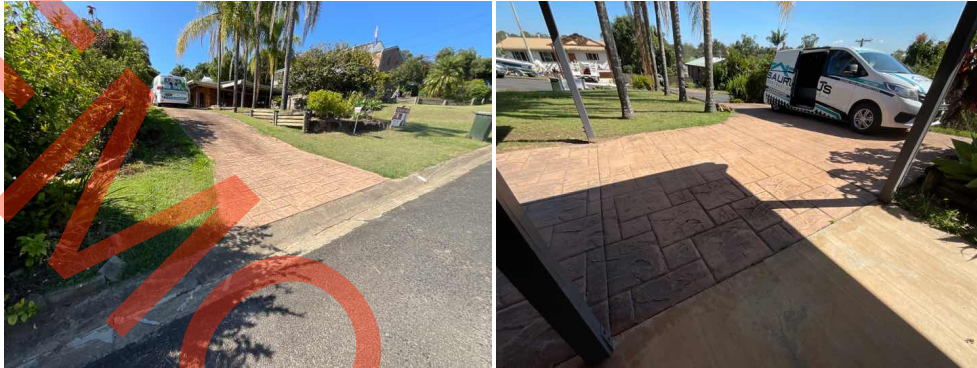
Driveway Condition

Common cracks were observed on the driveway. Whilst these cracks appeared to be typical at the time of inspection, we strongly recommend you monitor these cracks and if worsening occurs contact a concreter for further advice.

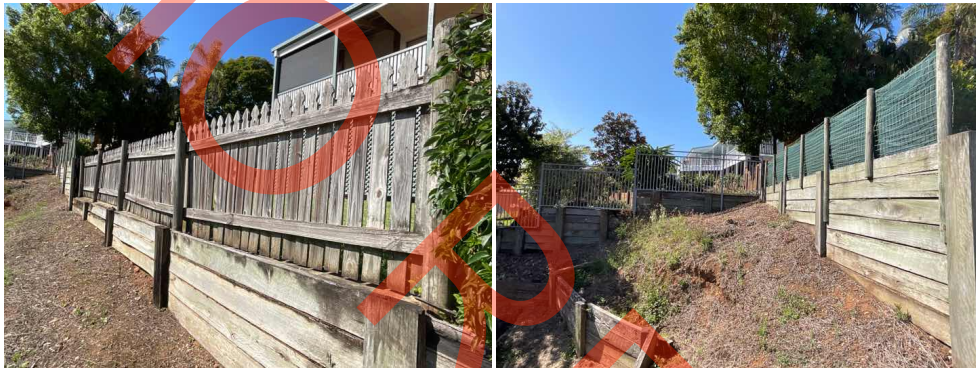
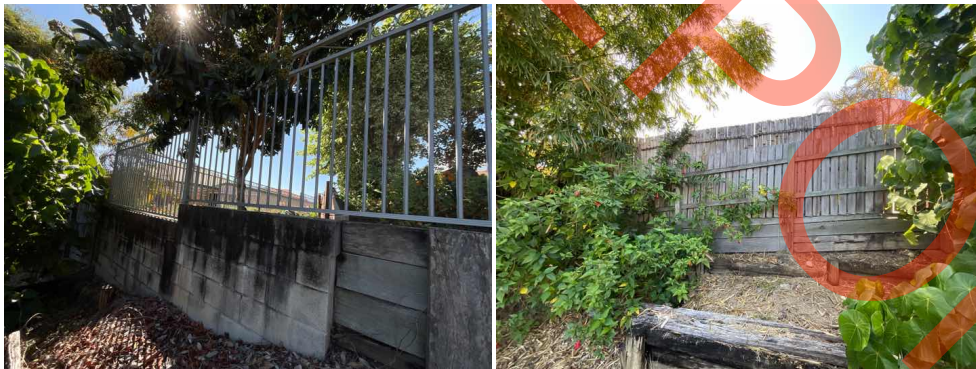
Fences & Gates

General age to fence components. General upkeep and maintenance required. A qualified fencing contractor should be engaged for repairs.

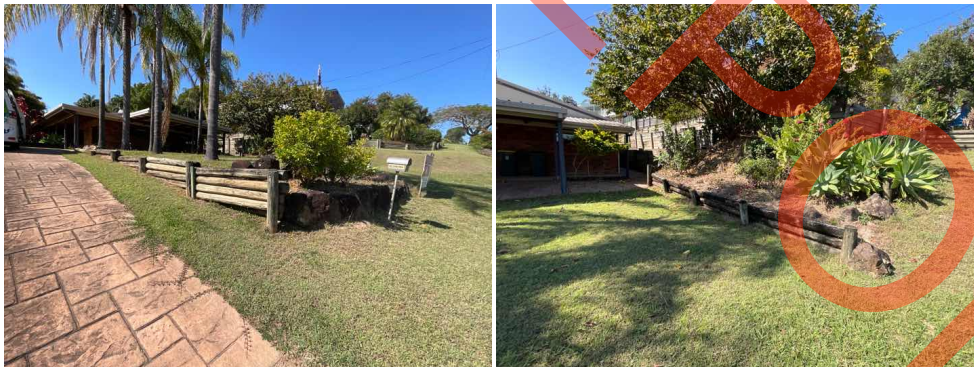
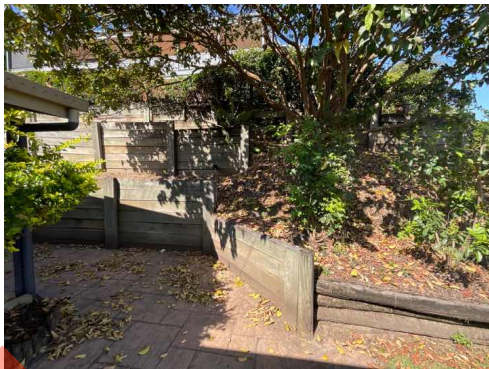
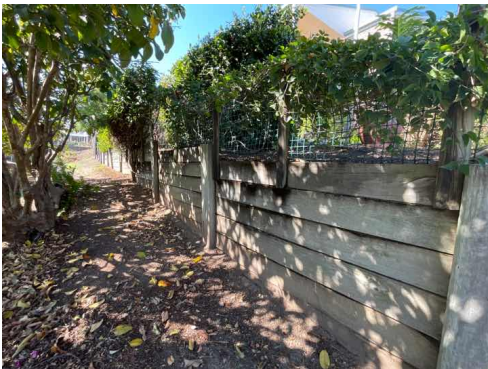
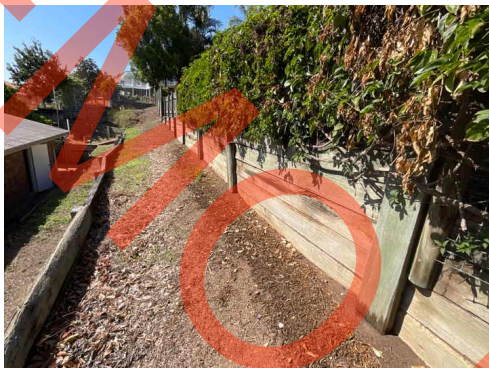
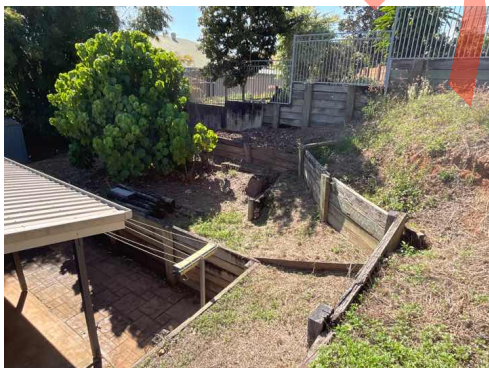
Retaining Walls

Retaining wall leaning due to deterioration and age. A qualified brick layer should be engaged for advice and recommendations.

Termite damage noted. We recommend you contact a licensed pest controller for further assessment, treatment and eradication in accord with AS3660

Due to the height and the potential for injury in the event of a fall. It's strongly recommended a safety barrier/ balustrade be installed.

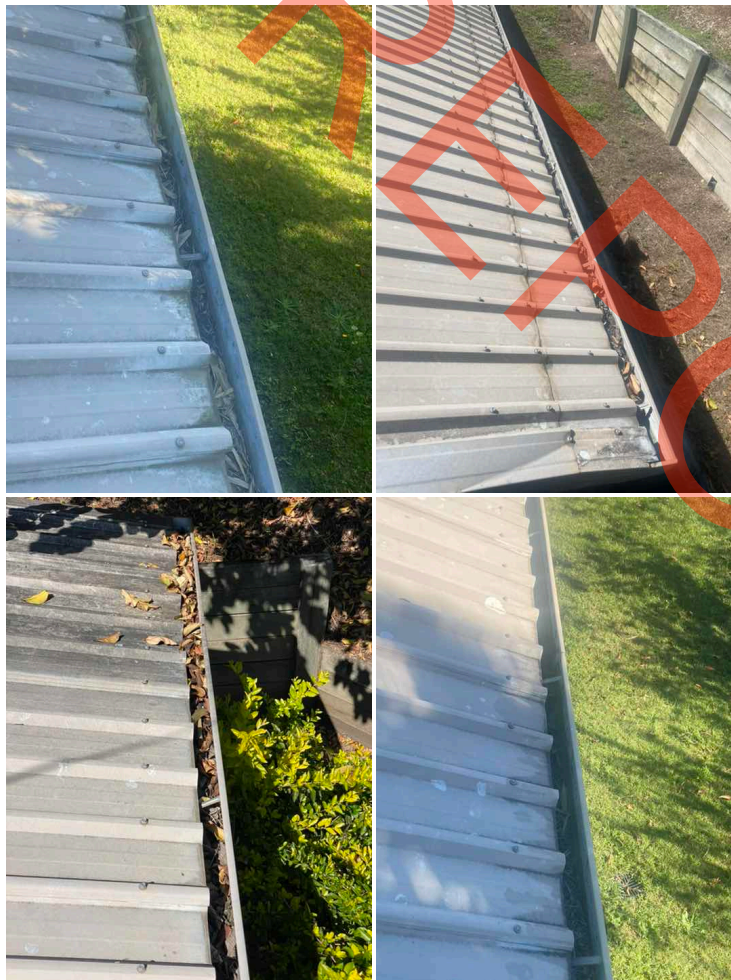
The gutter clips have detached in areas. Recommendations: This can be rectified by maintenance contractors. Debris in guttering areas- this requires cleaning out to prevent blocking of downpipes and leaking into eaves and fascia. Have gutters cleaned and assessed by a plumber for adequate fall. Regularly clean to prevent ponding. Ponding water will contribute to rust.

Gutter surface rust in sections- the rust is yet to penetrate and repairs/sealing may be an option. A qualified roof plumber should be engaged for advice and recommendations.

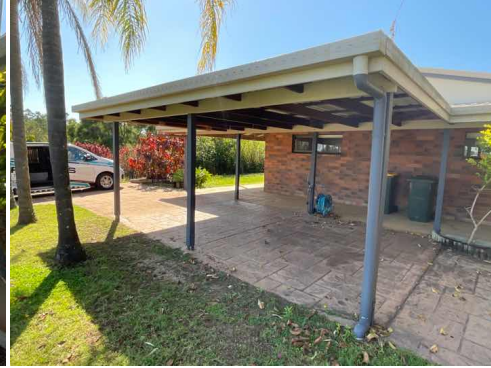
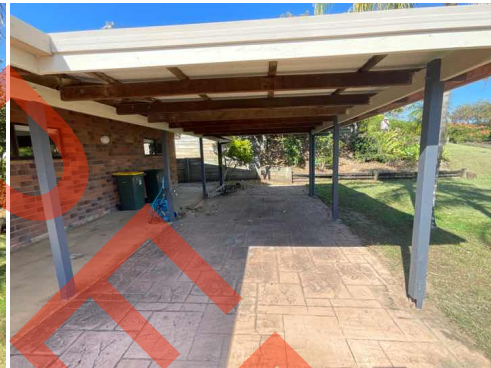
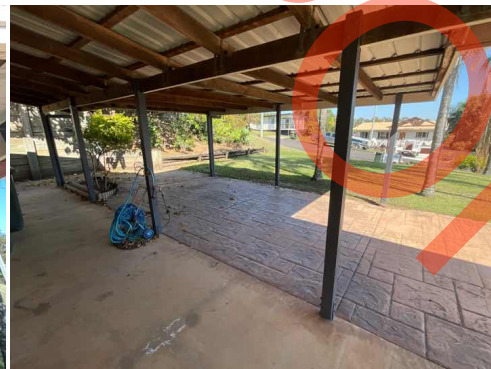
Minor rust on carport roof sheeting. A qualified roof plumber should be engaged for advice and recommendations.

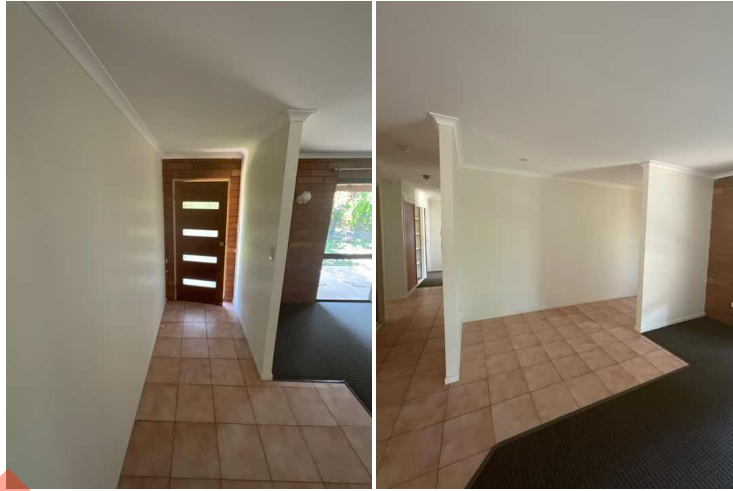
Flooring

Cracked floor tiles noted. A qualified tiler should be engaged for repairs.

Drummy/loose tiles observed. Tile lift and further deterioration likely. Contact a qualified tiler for repairs.

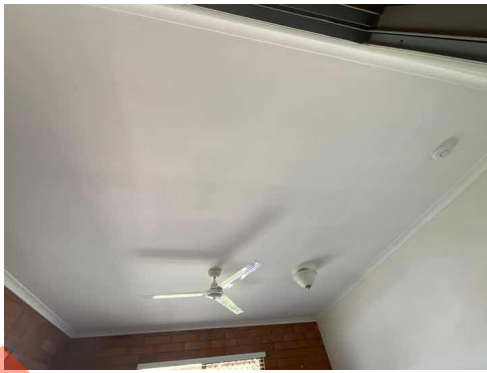
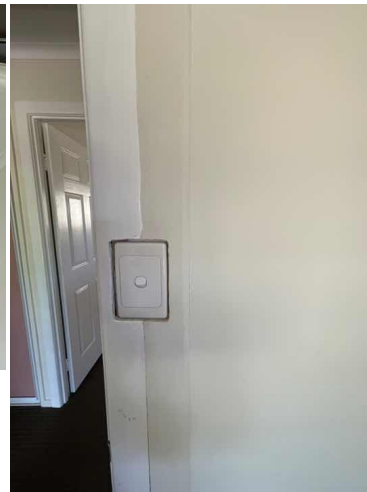
Walls

General ageing and/or denting and the like is evident on wall linings - Recommendations: A qualified painter should be engaged to assess and repair as required.

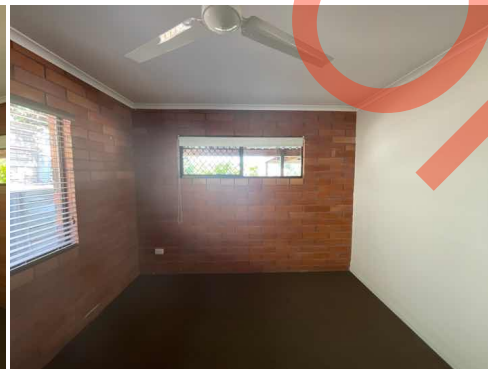
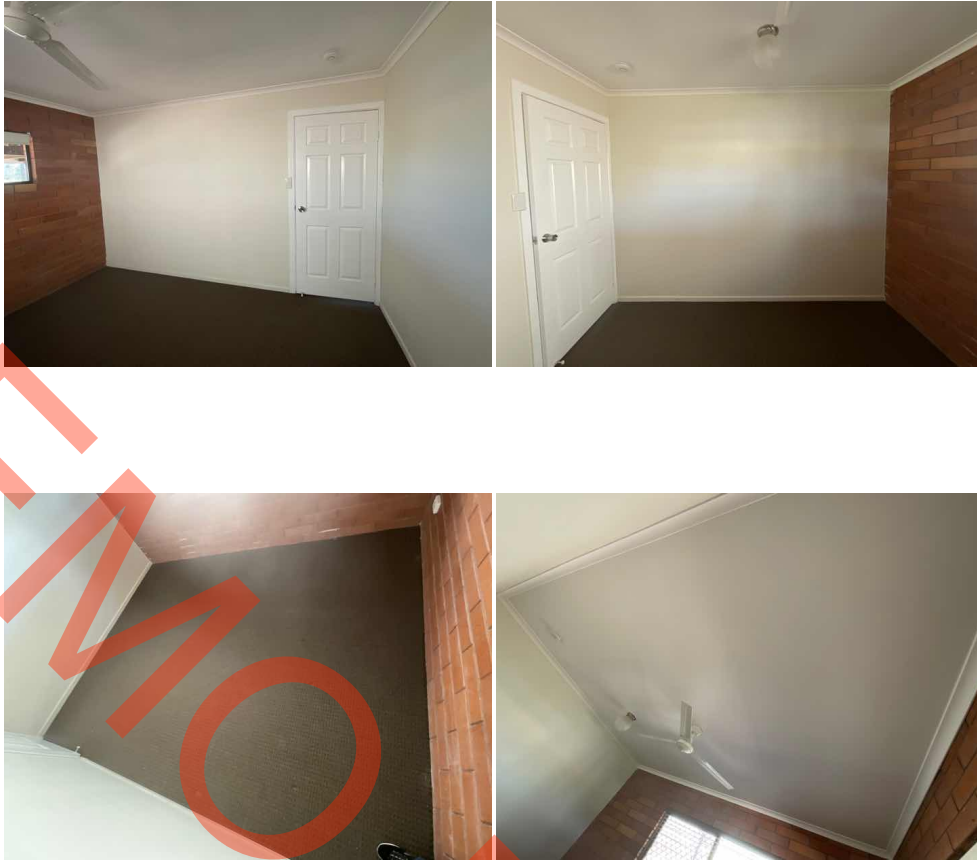
Walls

Settlement Cracks Noted. These are typical and generally patch and paint will suffice, however we recommend monitor these cracks and if become wider or longer, you will need to contact a structural engineers to assess.

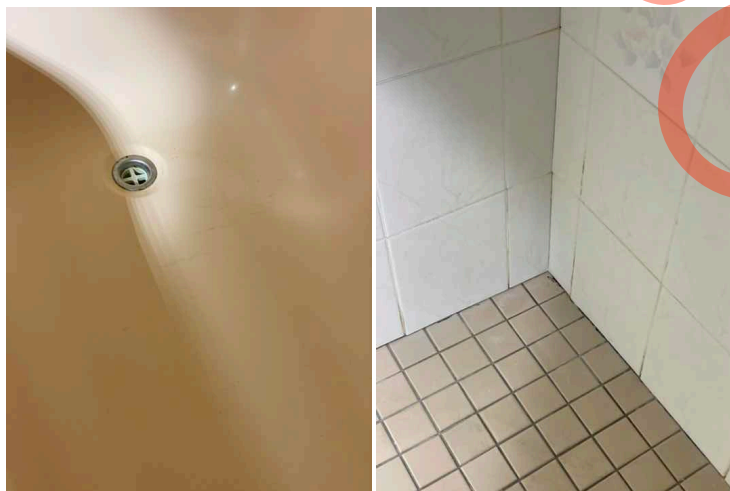
Shower And Bath

The bath tub is deteriorate. Refinish or replace. Contact a qualified plumber for recommendations and repairs
Tile grout deterioration to tiles to the shower area. Re-grout / seal. A qualified tiler should be engaged
recommendations and repairs as water may seep in causing rot and creating conducive conditions termites.
