Building & Pest Inspection

Saurus Constructions PTY LTD

Pest And Building Inspection

The Scope of the Inspection: This report Complies with Australian Standards AS 4349.1-2007. Inspection of Buildings Part 1: Pre- Purchase Inspections-Residential Buildings- Appendix "C" and with AS 4349.3-2010 (Visual Timber Pest Inspection Report)

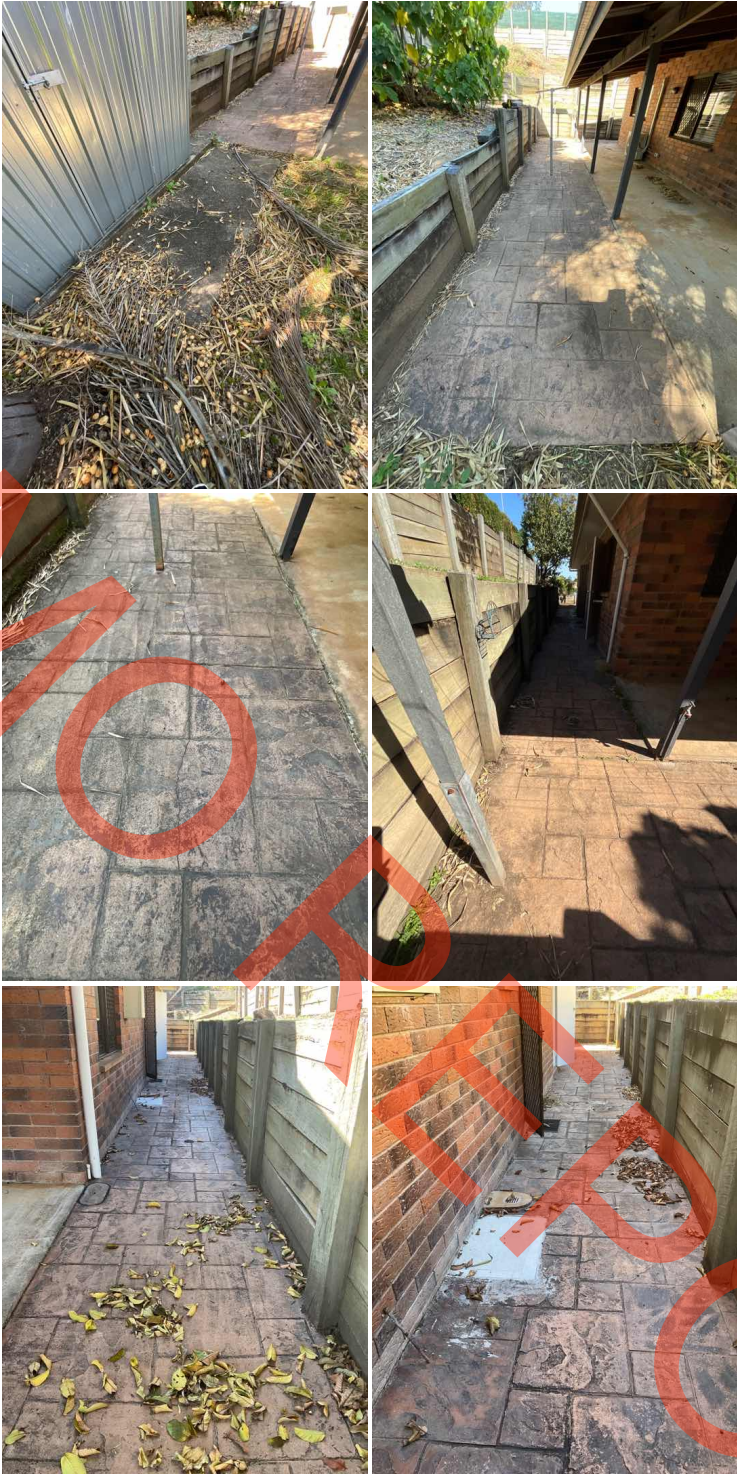
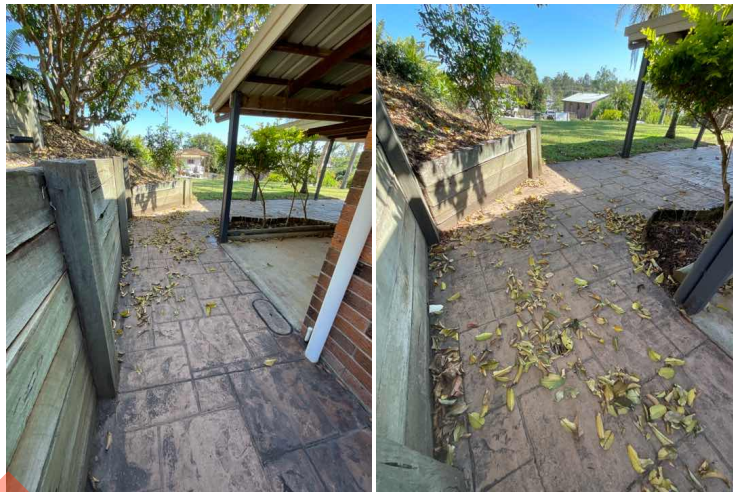
Pathways Condition

The paths around the home are in a serviceable condition for the age of this dwelling with no major defects visible.

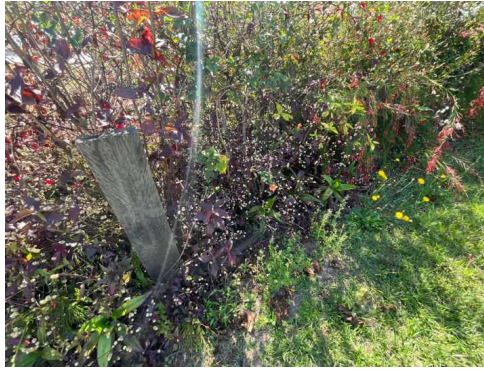
Overall Condition

General age to fence components. General upkeep and maintenance required. A qualified fencing contractor should be engaged for repairs.

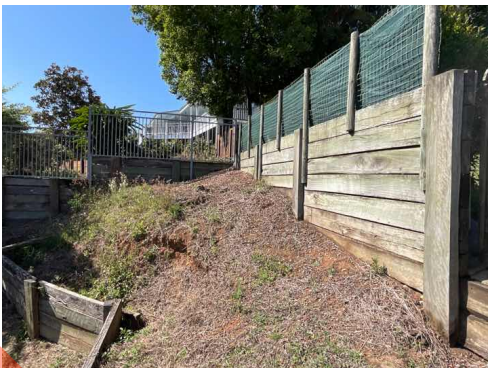
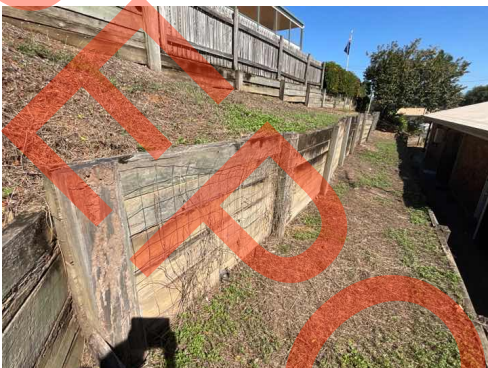
Overall Condition

Retaining wall leaning due to deterioration and age. A qualified brick layer should be engaged for advice and recommendations.

Termite damage noted. We recommend you contact a licensed pest controller for further assessment, treatment and eradication in accord with AS3660

Due to the height and the potential for injury in the event of a fall. It's strongly recommended a safety barrier/ balustrade be installed.

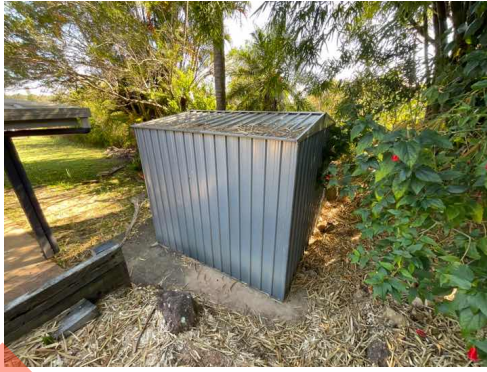
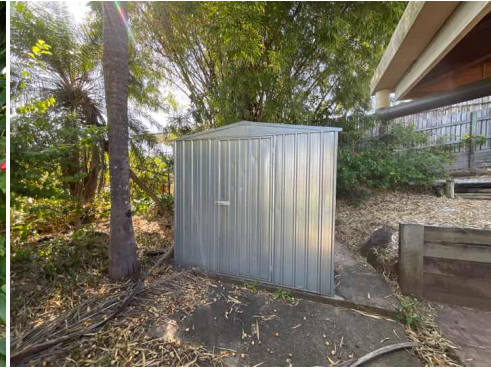
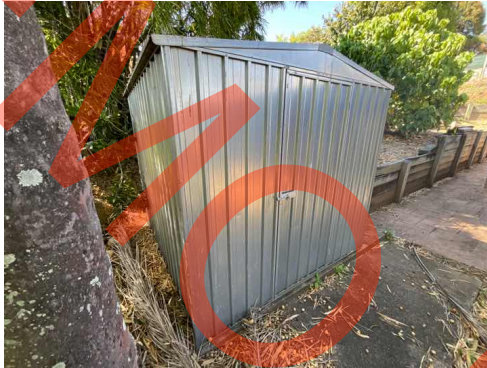
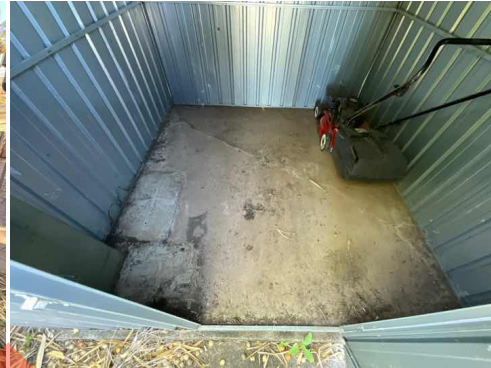
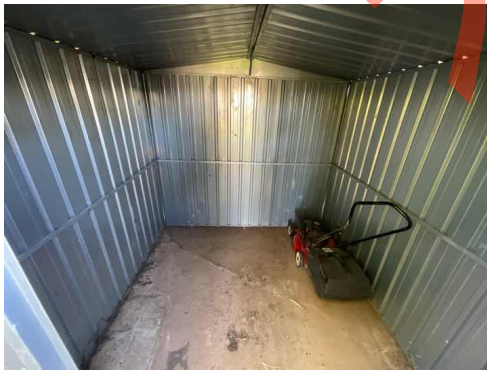
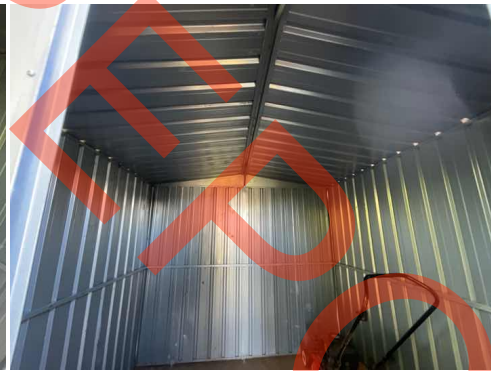
Shed Condition

The shed is in fair usable condition.

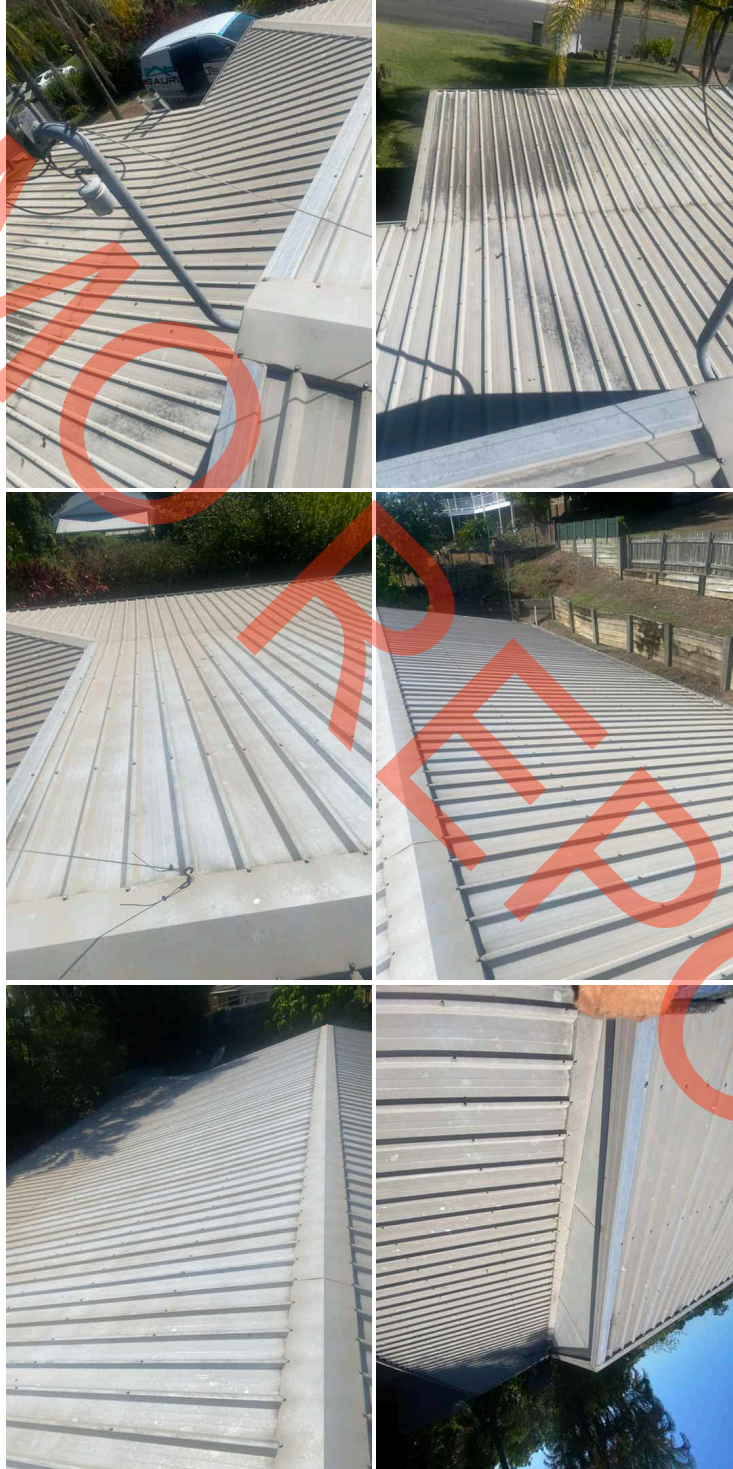
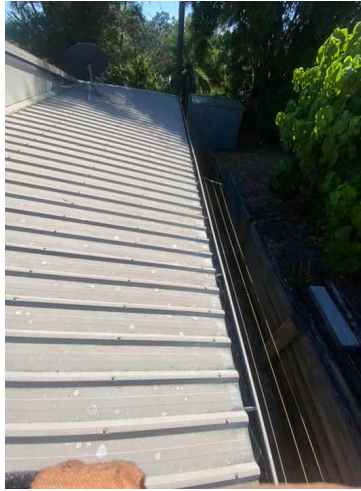
Overall Condition

Of the visible areas, the general condition of the roof is in serviceable condition for the age.

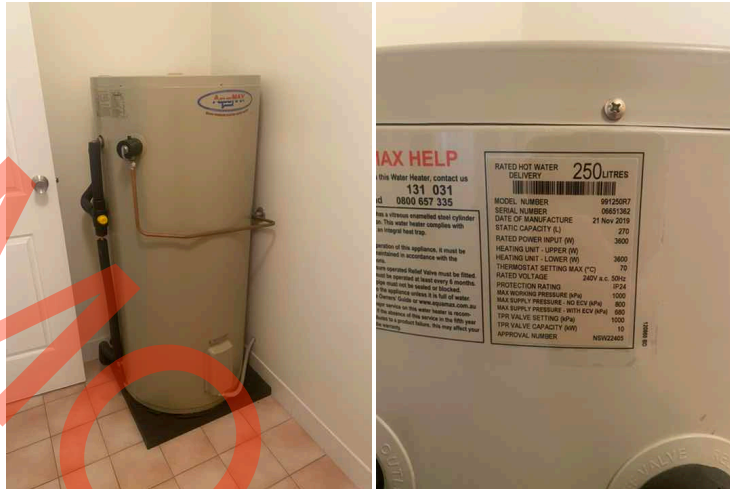
Hot Water Unit Findings

The hot water system appears to be in a serviceable condition. No specific tests other than running the hot water from a tap was carried out. No determination has been made as to the suitability or adequacy of the hot water system in relation to capacity or otherwise.

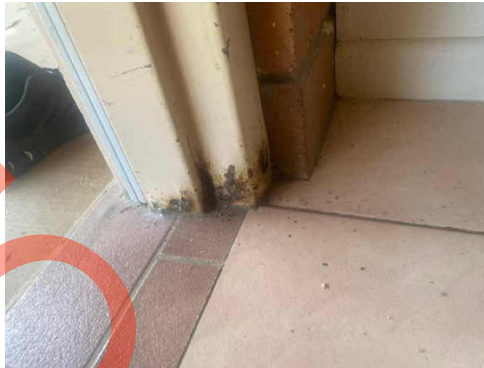
Door Findings

Rust in door/door frame - Recommendations: General repairs required.

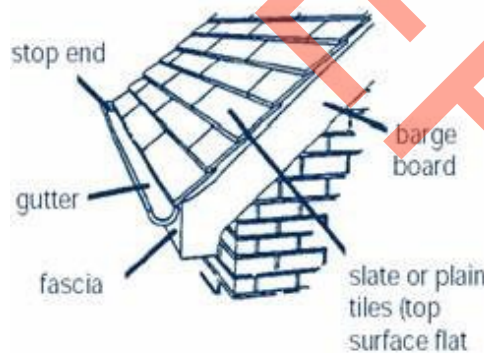
Condition

On visual inspection, the general condition of the fascia/barge boards is serviceable.

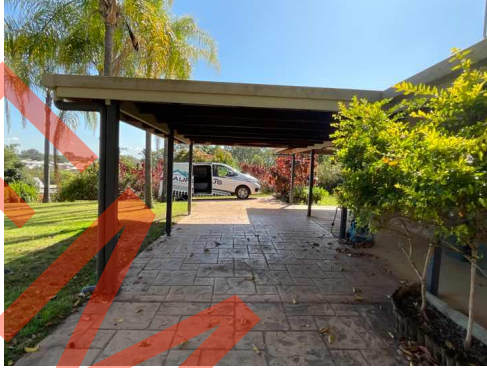
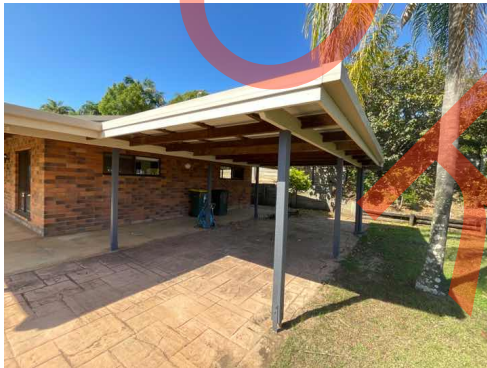
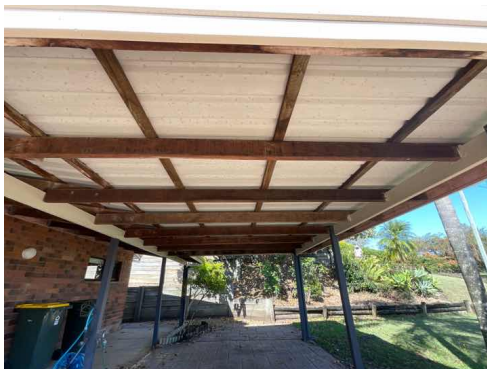
Overall Condition

Defects exist to this area or component/s requiring assessment by a specialised field. Please read below for details.

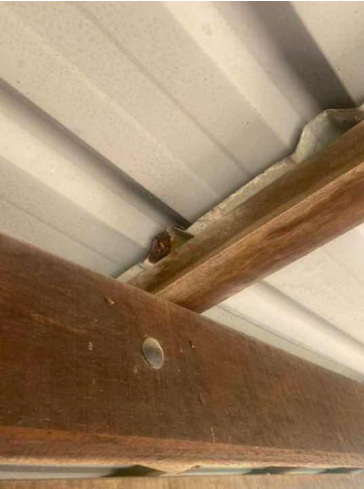
Roof Findings

Minor rust on carport roof sheeting. A qualified roof plumber should be engaged for advice and recommendations.

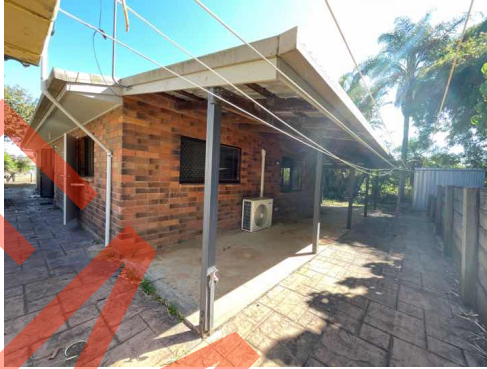
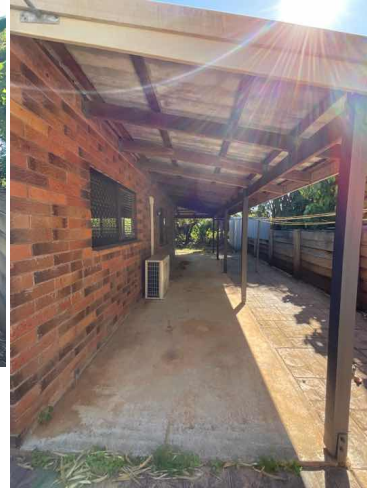
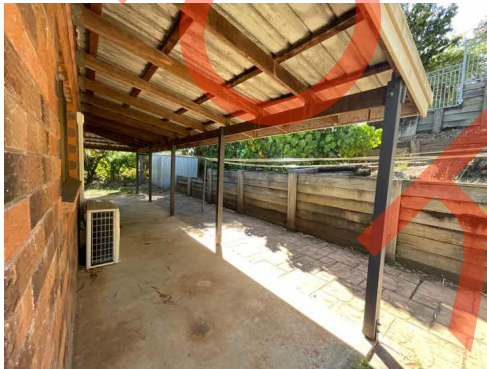
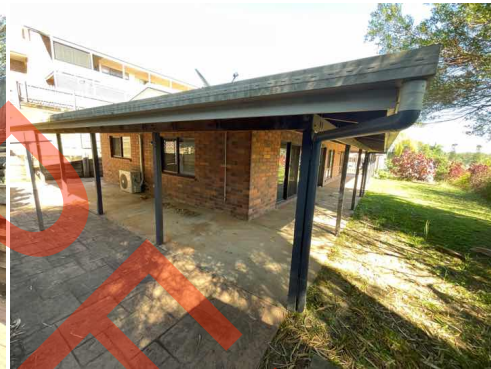
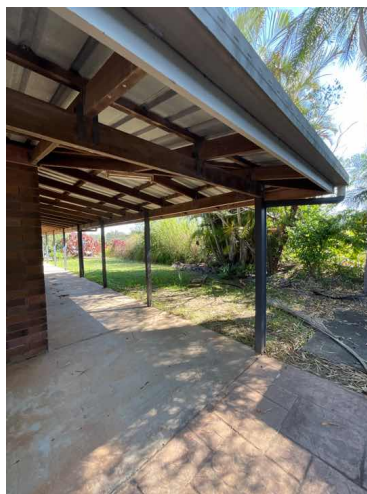
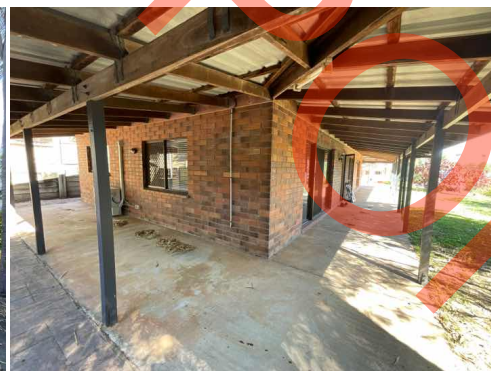
Overall Condition

Though we are not structural engineers the veranda/s appear to be in a serviceable condition.

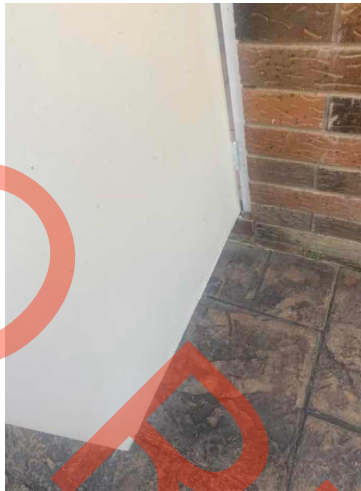
Damp damage to door/frame. Replacement recommended.

Recommendations: A qualified carpenter should be engaged for advice and recommendations.

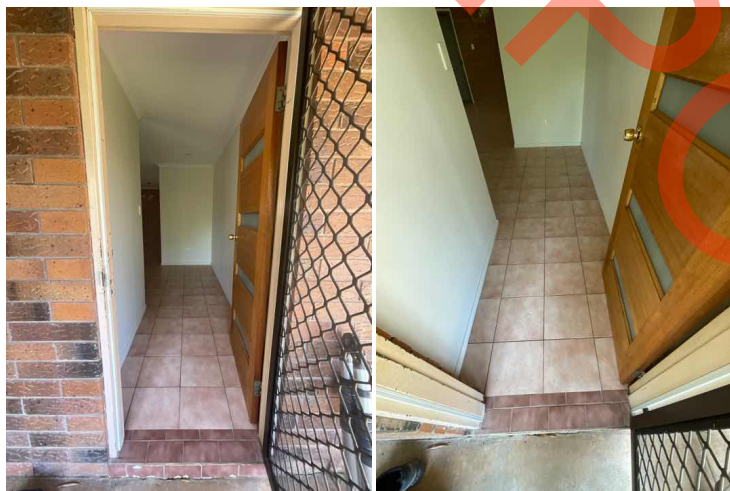
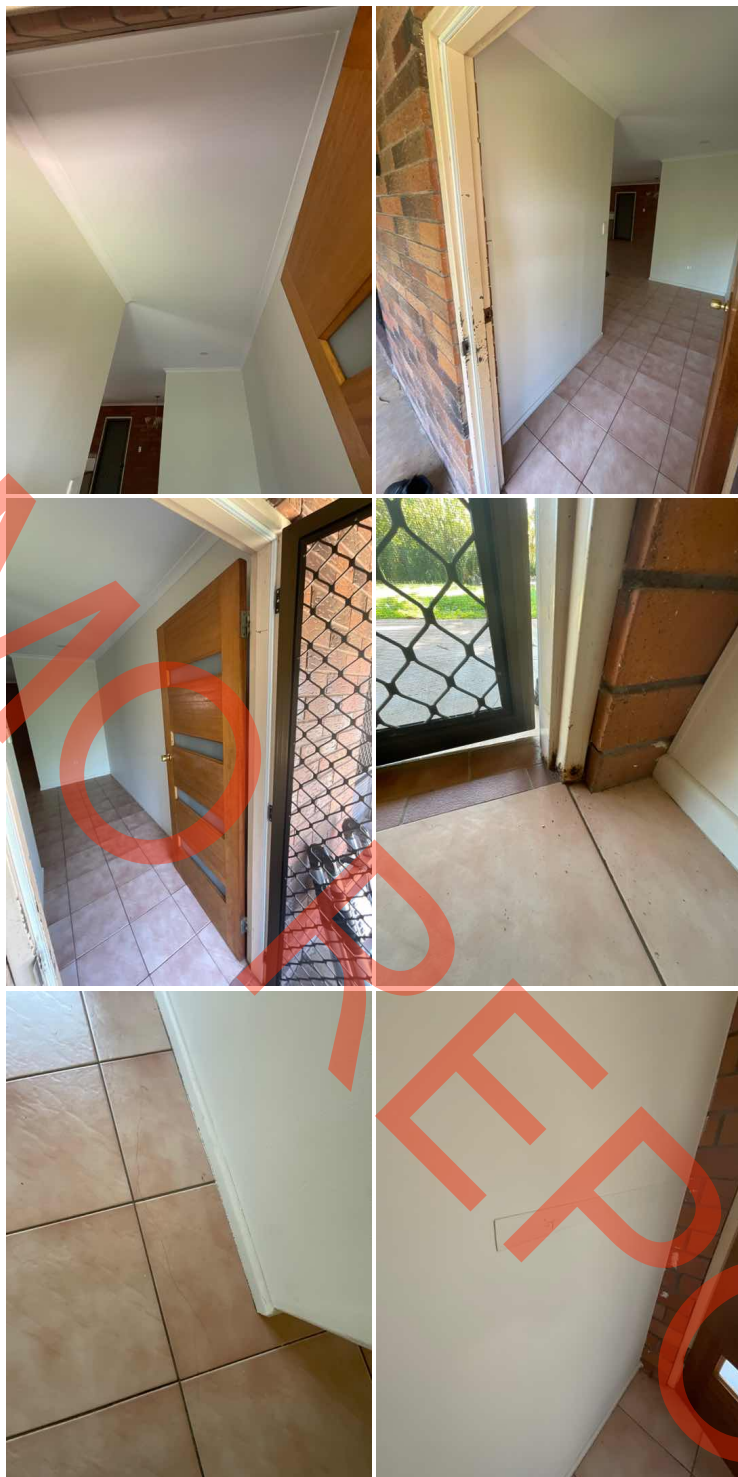
Overall Condition

On inspection, defects were present that will require further assessing and recommendations by a qualified trades persons, please read below for details.

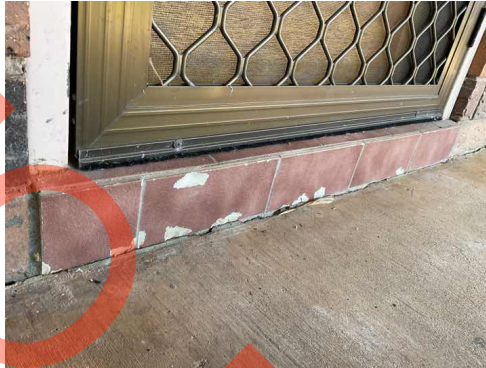
Flooring

Cracked floor tiles noted. A qualified tiler should be engaged for repairs.

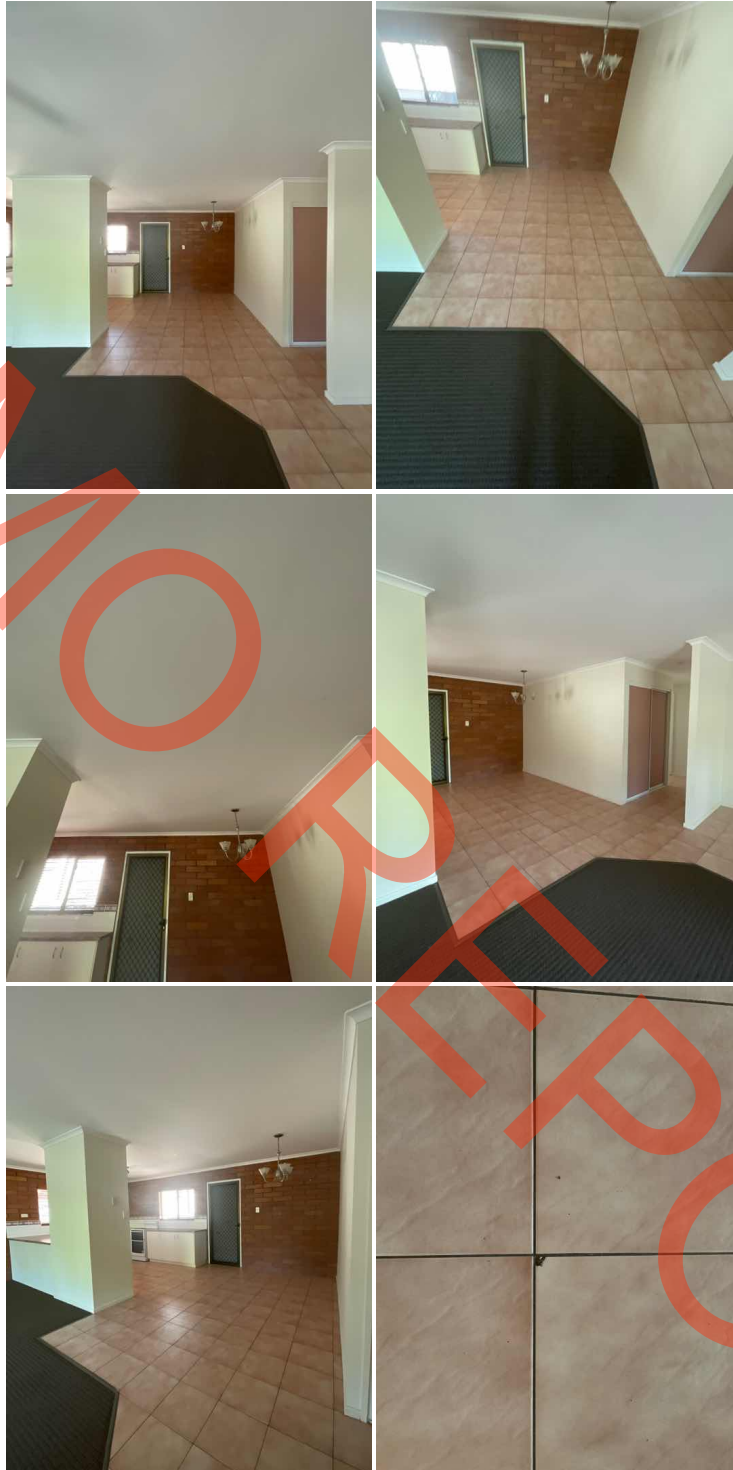
Ceiling

General ageing and/or denting and the like is evident on ceiling linings - Recommendations: A qualified painter should be engaged to assess and repair as required.

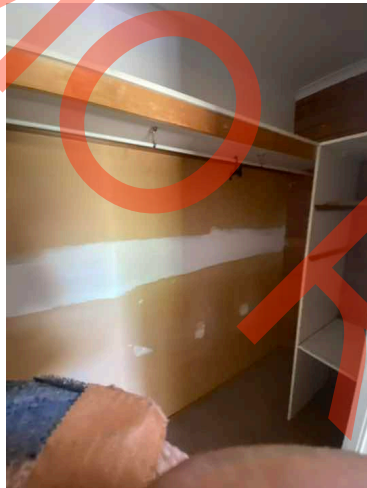
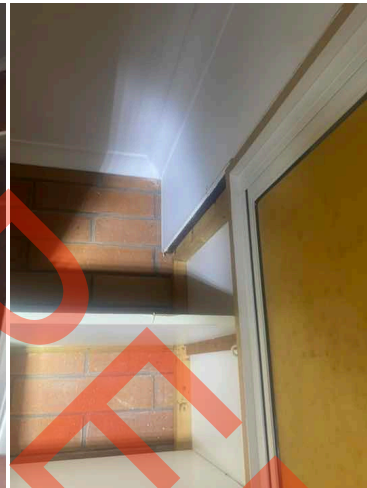
Walls

General ageing and/or denting and the like is evident on wall linings - Recommendations: A qualified painter should be engaged to assess and repair as required.

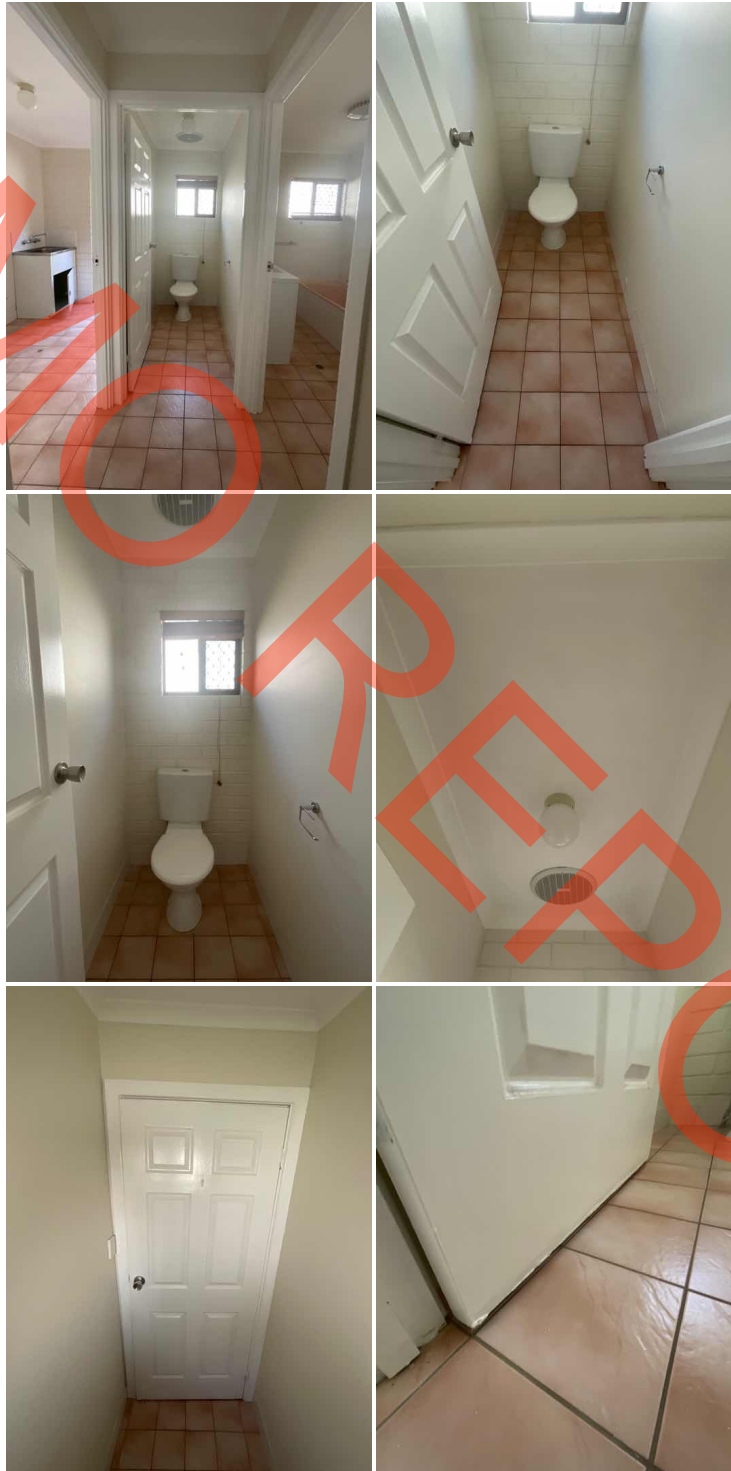
Door

Binding/out of square door frame - This can relate to some differential settlement in the footings, frame movement, age, expansion, shrinkage and the like. A qualified carpenter should be engaged for advice and recommendations.

Water damaged door. Possible due to leak in bathroom. Replacement recommended.

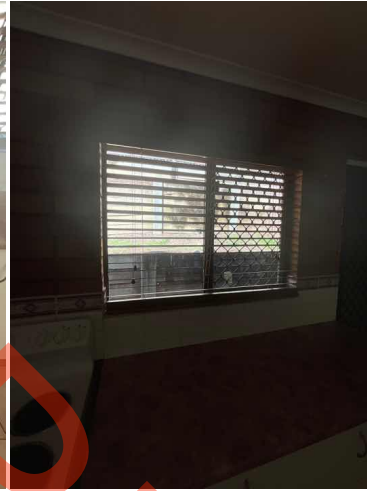
Ceiling

General ageing and/or denting and/or wear and/or previous wall patching and the like is evident on ceiling linings
- Recommendations: A qualified painter should be engaged to assess and repair as required.

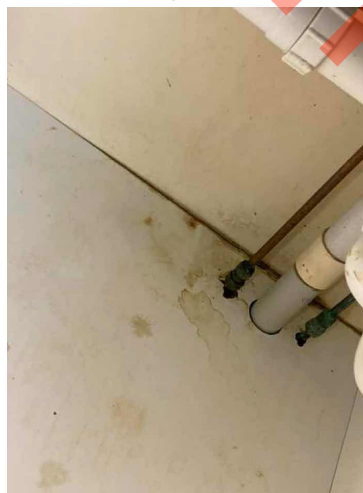
Cupboards And Bench Tops

Water damage to cabinet observed. Replacement required. Contact a cabinet maker for repairs.

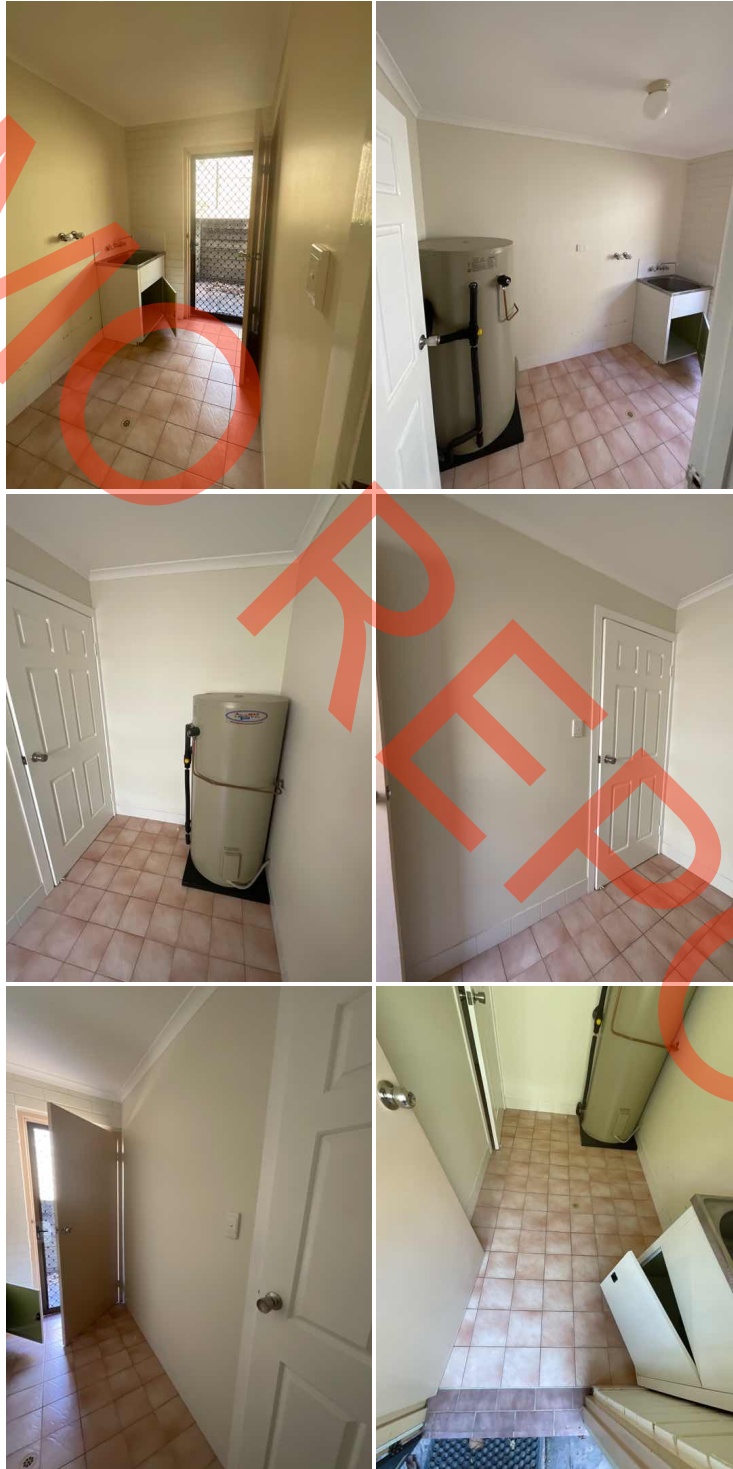
Walls

General ageing and/or denting and/or wear and/or previous wall patching and the like is evident on wall linings -
Recommendations: A qualified painter should be engaged to assess and repair as required.

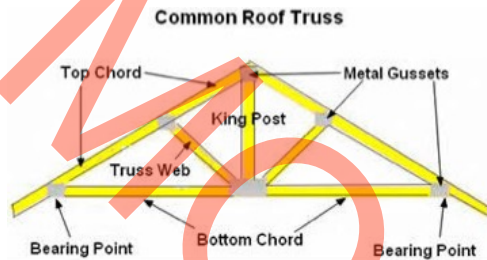
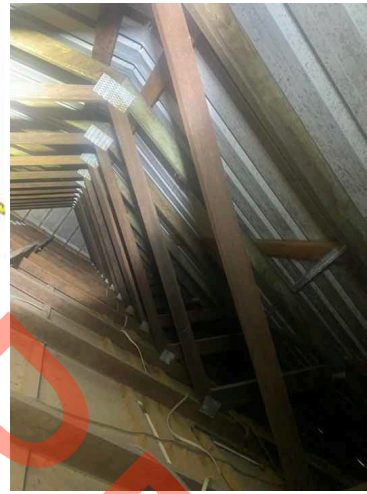
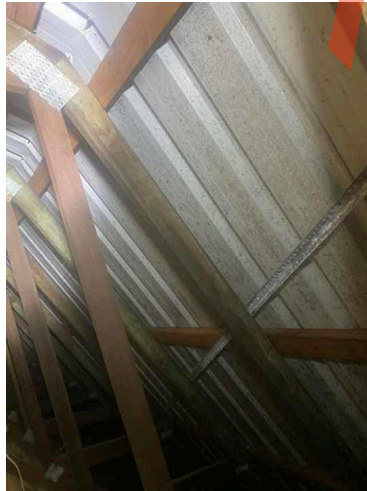
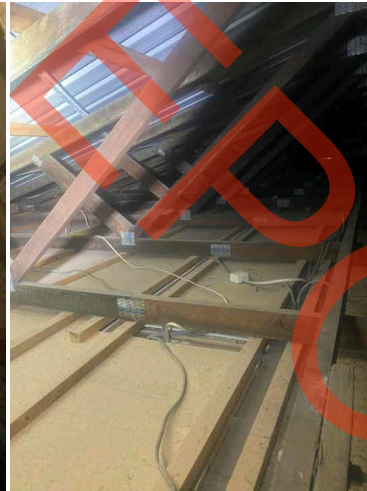
Roof Frame Type

The roof frame is a truss timber frame.

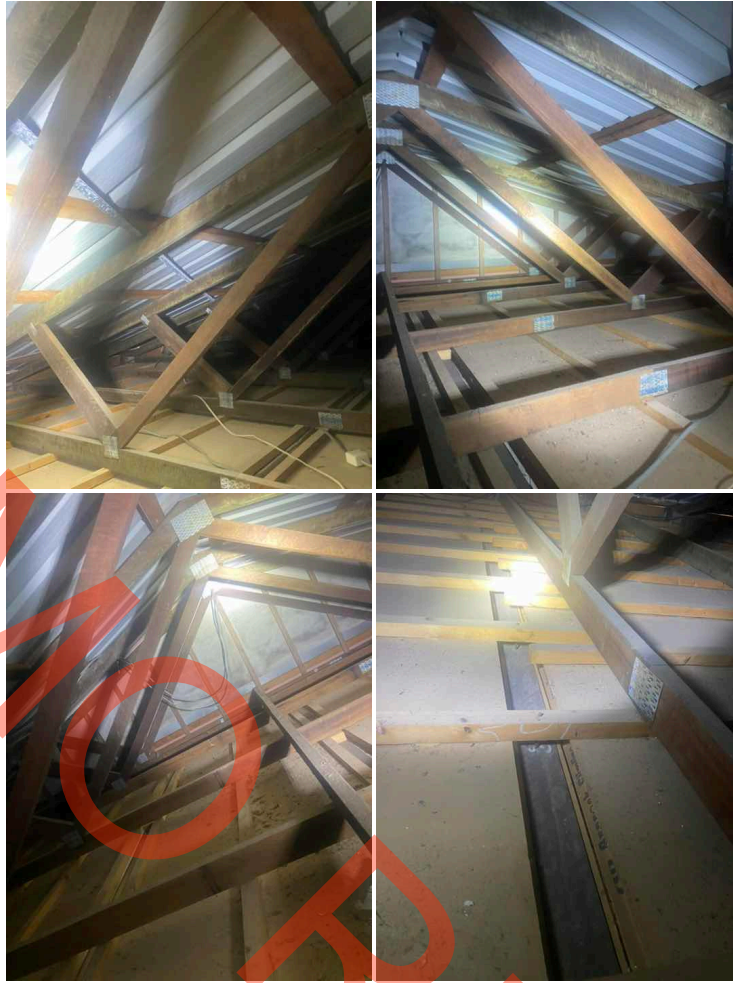
Overall Condition

Visible sections of the roof void is in a serviceable condition for age of this dwelling.

No insulation installed. Recommendations: Engage insulation contractor to assess.

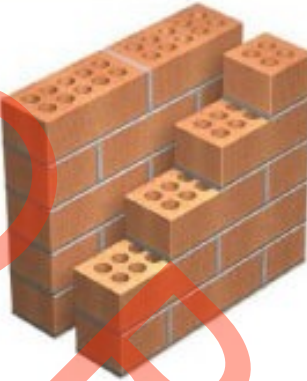
DOUBLE BRICK WALL

The structure is of full (Double) brick construction.

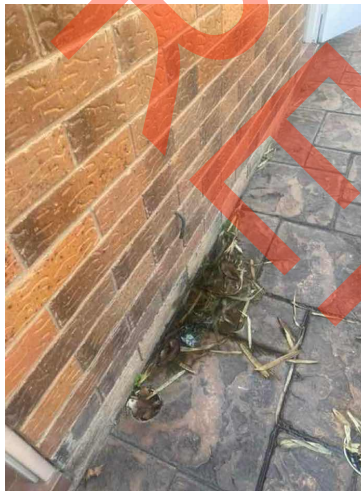
Was the overflow sufficiently drained

No. Divert hot water overflow away from the building perimeter.
